CONSTRUCTION MANAGEMENT OF A WATER MANAGEMENT PROJECT,  
WERTHEIM NATIONAL WILDLIFE REFUGE, SHIRLEY, NY.

*Poster Presentation*

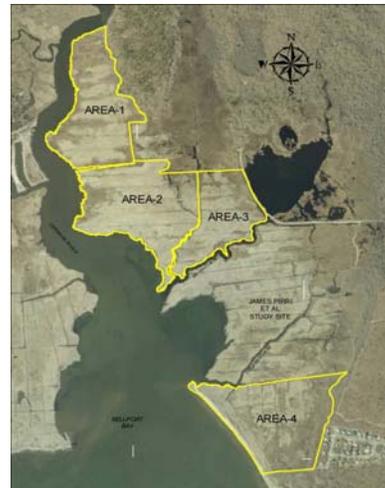
Figure 2 – Project area

The basic project was to modify two 40 acre portions of the approximately 600 acres of tidal marsh in the refuge. Ponds of varying sizes were to be constructed, with the spoils from the ponds being used to fill the mosquito control ditches and to eliminate hummocky areas of the marsh that supported mosquito breeding. A channel was to be dug around the landward side of one marsh area to increase tidal flows to spots where *Phragmites* were prevalent. Several ditches that were not filled were to be “naturalized” by adding curvature to their previously linear layout. All ponds were to be connected to tidal waters to enhance water quality to support fish.

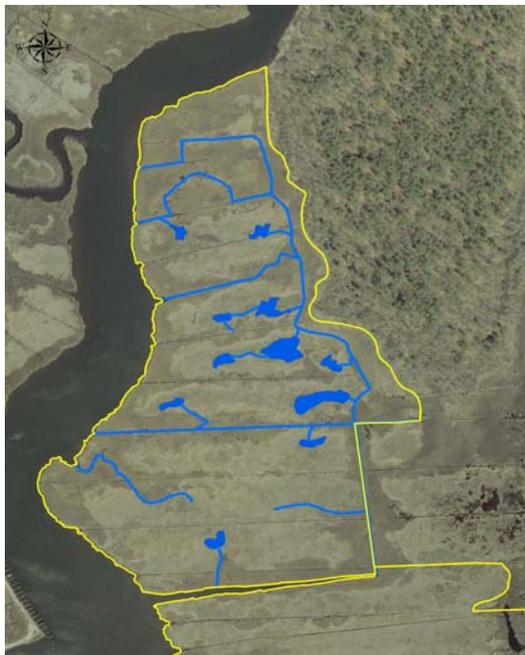
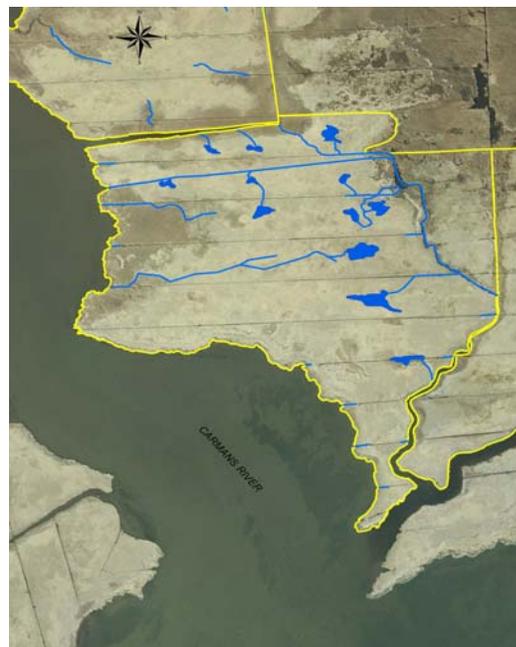
Figure 2 and 3 – Water management in Areas 1 and 2.

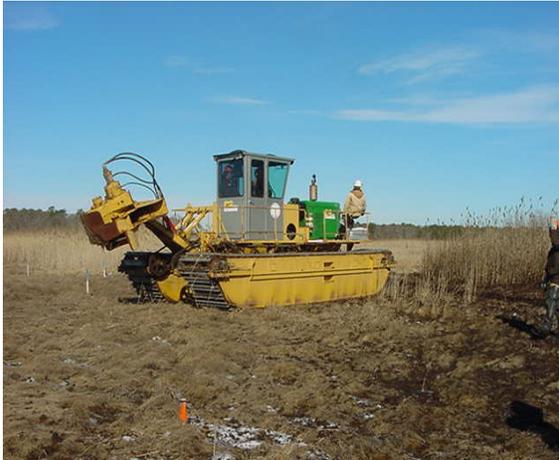
Figure 4 - Quality ditcher modified with “low-ground pressure” tracks. Environmental monitor on deck assessing environmental impact during operation.

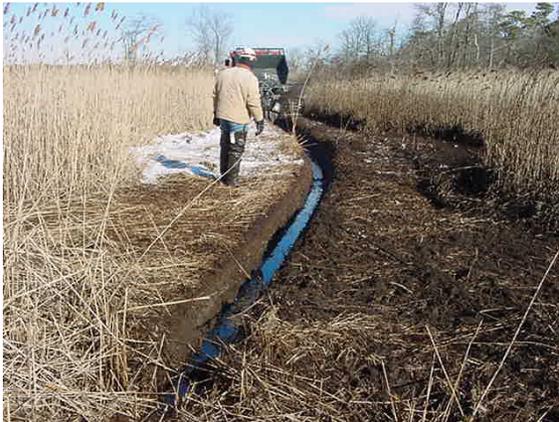
Figure 5 - Pisten Bully creating tidal channel along landward side of Area 1. In order to mitigate potential spreading of *Phragmites*, the soil from tidal channel along this portion of the marsh was deposited upland into an existing *Phragmites* stand. Environmental monitor in foreground.

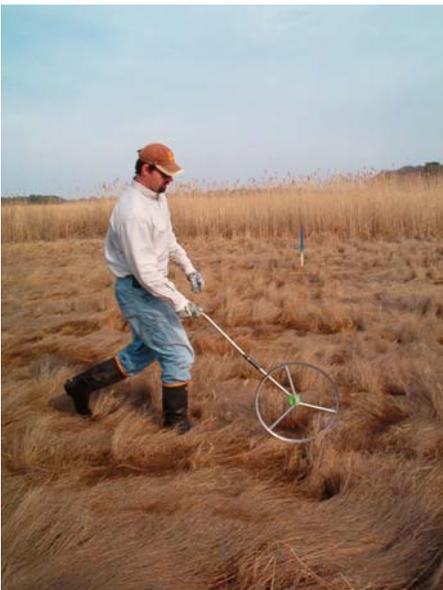
Figure 7 - Each pond and channel was measured and staked. Each stake location was recorded using a GPS and crossed checked with the GIS design.

Permit compliance was achieved through GIS design of the project elements. The drawings were translated to the field by staking all important features based on GPS coordinates derived from the GIS design. This attention to detail was maintained through the biological observers (see just below) who monitored the construction of features and compliance with the staking array.

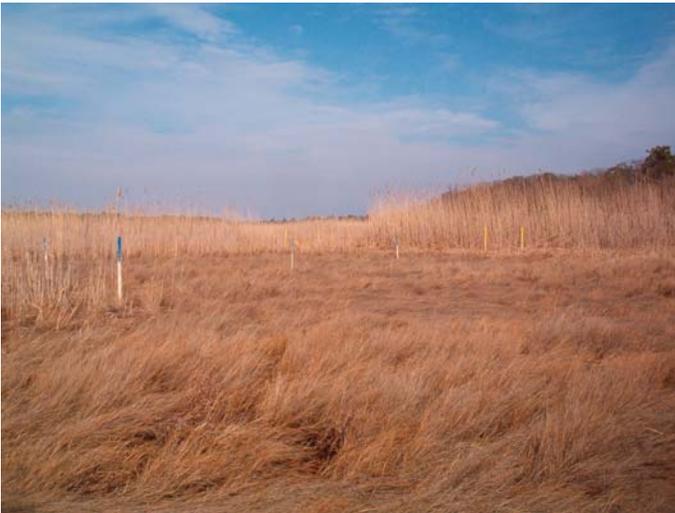
Figure 9 - Pond staked and ready for management implementation.

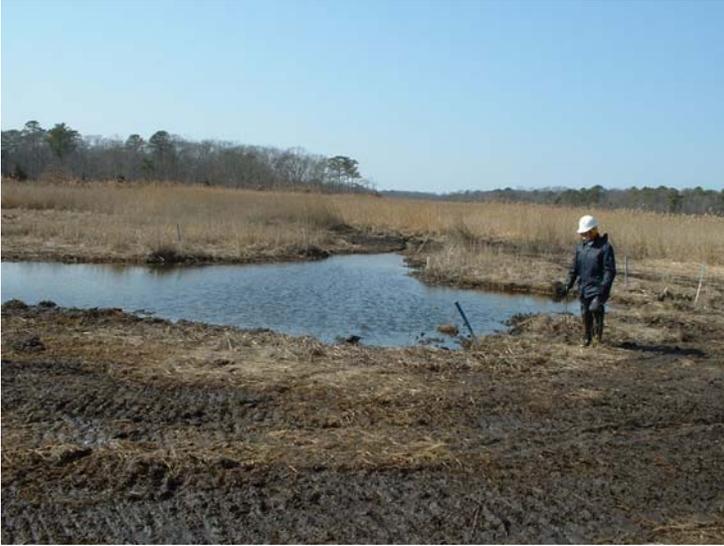
Figure 10 - Monitor verifying location of pond with markers.

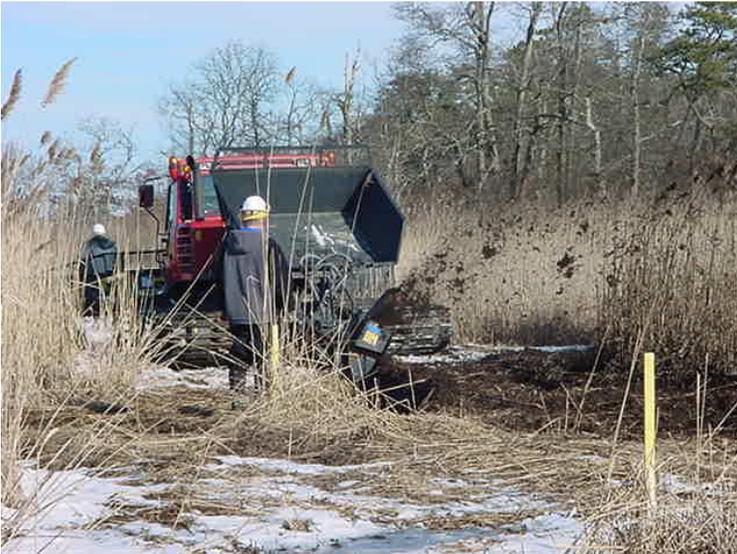
Figure 11 - Monitor watching Pisten Bully cutting tidal channel in Area 1 to ensure track follows markers.

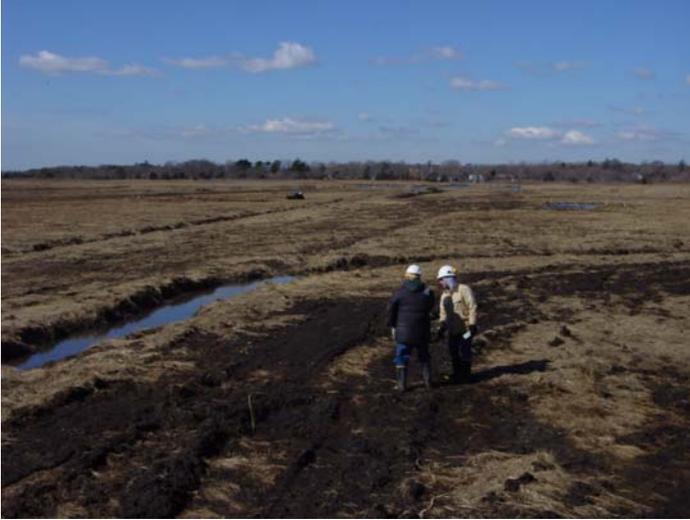
Figure 12 - Two monitors verifying location of tidal creek to GIS design.

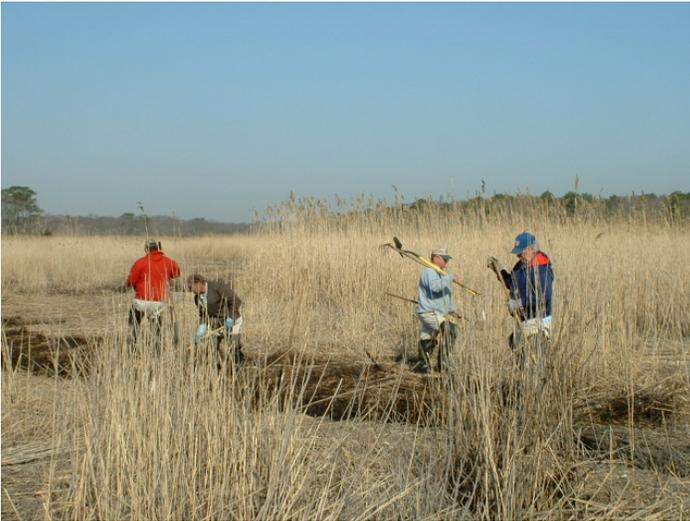
Figure 13 - To minimize impact from machinery, hand crews were deployed in areas of concern.

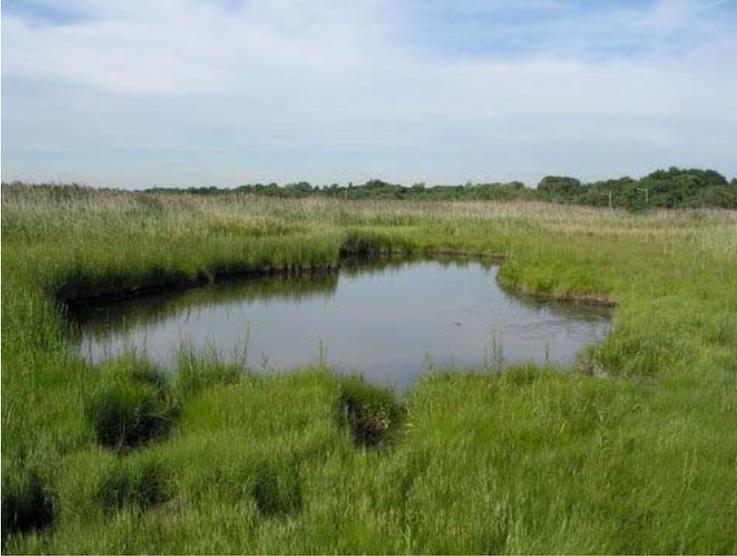
Figure 14 - Second growing season after management project in Area 1. During this photography event, observations indicated that this pond was teeming with fish.
