PHYSICAL MODELING OF DEFLECTOR ARMS IN A RIVER TABLE

by
Djibrilla Rapant
Candidate for Bachelor of Science
Environmental Resources Engineering
With Honors

May 2012

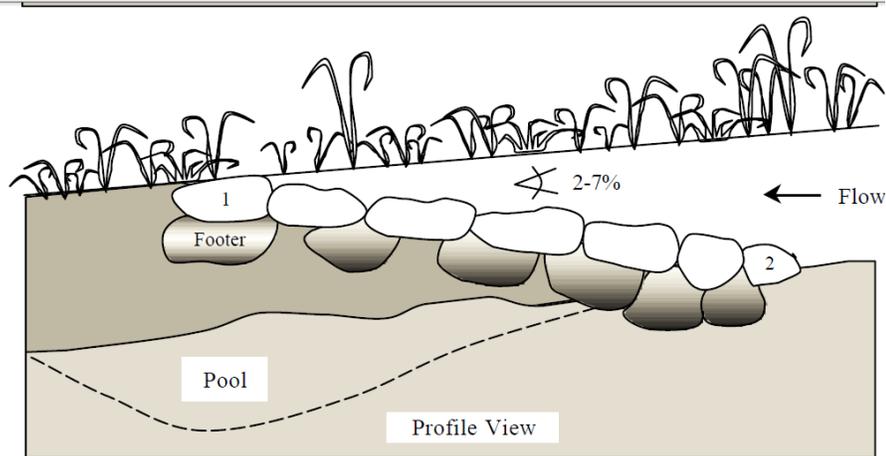
Figure 3: Profile View of Example Rock Vane

(Rosgen, 2001)

boulder width, roughness, and gaps. The deflector arm can be placed at a 20 to 30 degree angle from the bank, and the slope of the arm can be between 2 and 7 percent (Rollins, 2003). Although a 20 degree angle provides protection for the greatest length of stream bank (Rosgen, 2001) a 30 degree angle was used in experimentation due to ease of implementation. Profiles are shown in figures 3 and figure 4.

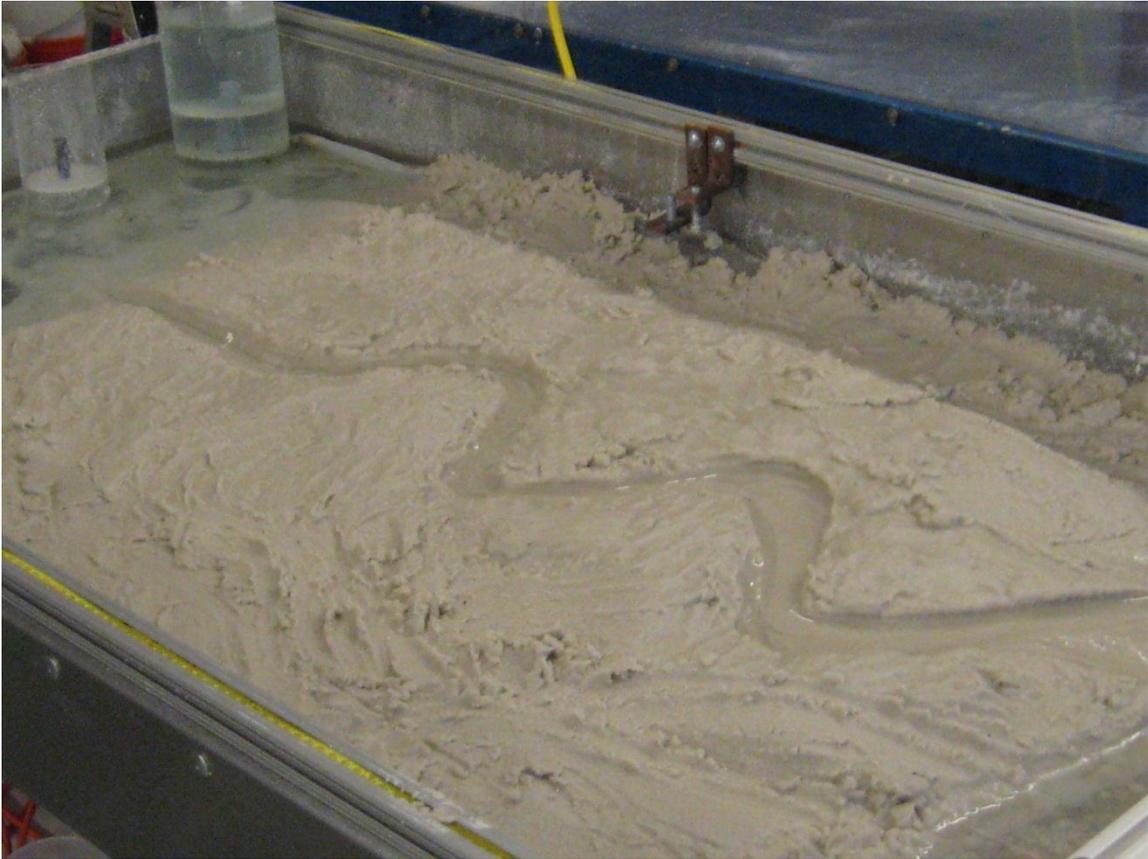
Figure 8: River Model

4. A fixed geometry channel was carved into the river table to test the deflector arms. The channel geometry was replicated to limit variability in flow geometry and flowrate between tests of the deflector arm models. Flow geometry describes the angles at which the river flow approached the deflector arm due to the meander planimetry of the channel. Flowrate control was imprecise due to sensitivity of river table pump controls, and observed variations in flowrate were recorded (see figure 7) and their effect was

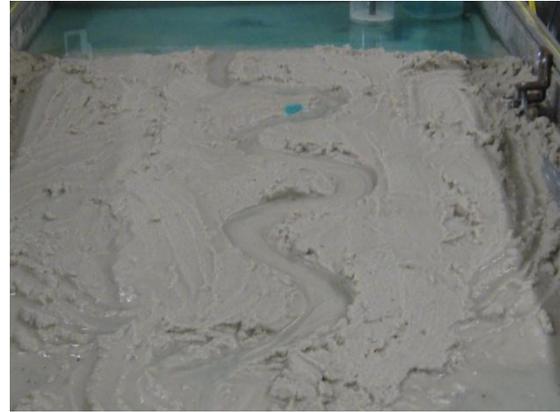
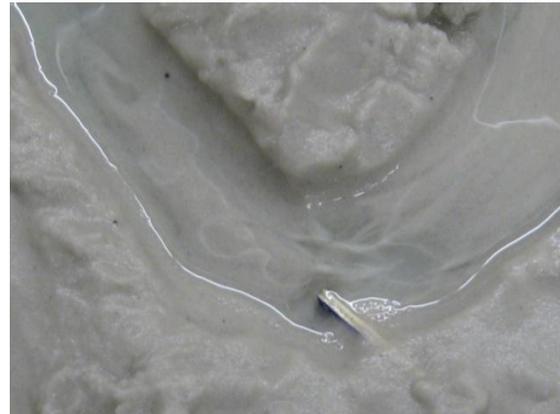
Figure 10: Test 2 Before and After
Before

After

structure 2 performed best of all structures due to low ranking in presence of erosion and hence minute change in stream geometry (see figure 10). By contrast, the photo analysis revealed structure 5 resulted in the greatest extent of downstream and bank erosion (see figure 11).
